Idaho Department of Environmental Quality  
2013 Drinking Water Supply Report

PWS #: **1280039**

Date: **June 11, 2013**

System: **Carlin Bay Property Owners Association**

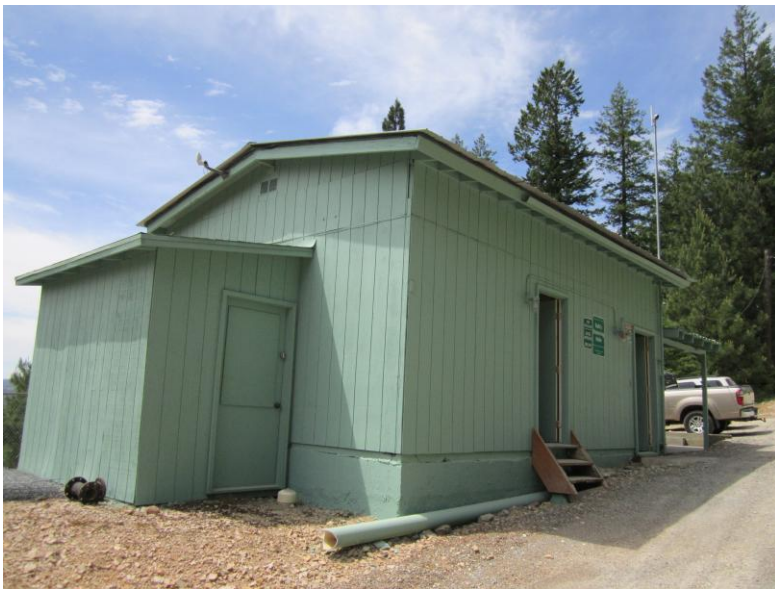
*Filtration treatment building (contact chamber below)*

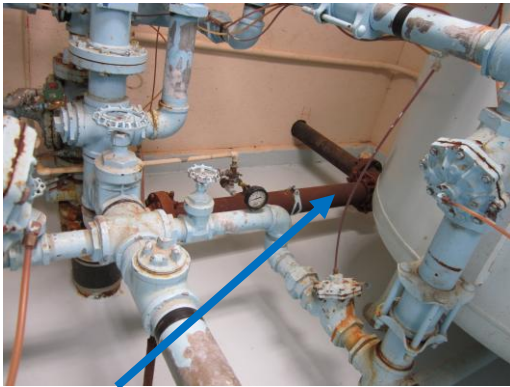
*Raw water feed line to plant*

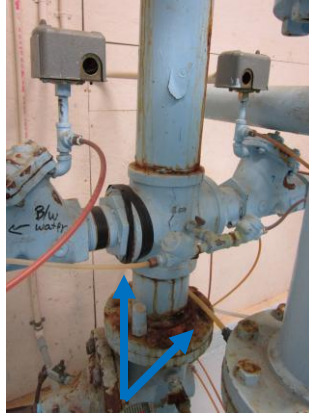
*Alum and chlorine injection*

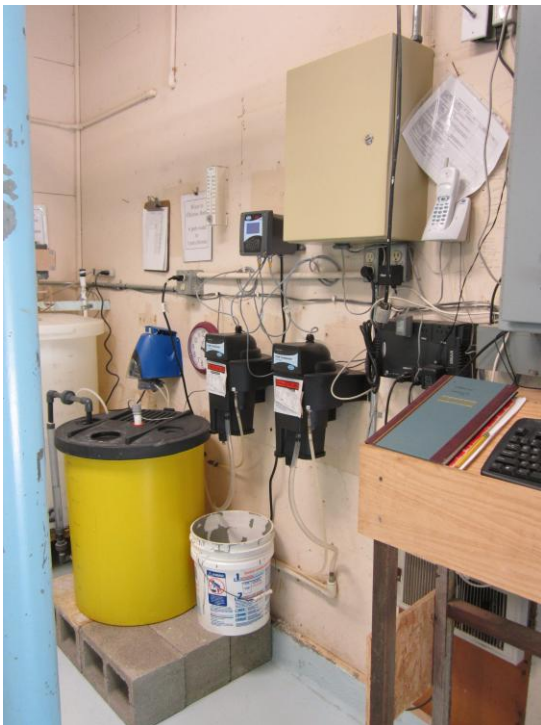
*NaClO day tank and metering pump  
1720E individual effluent turbidimeters*

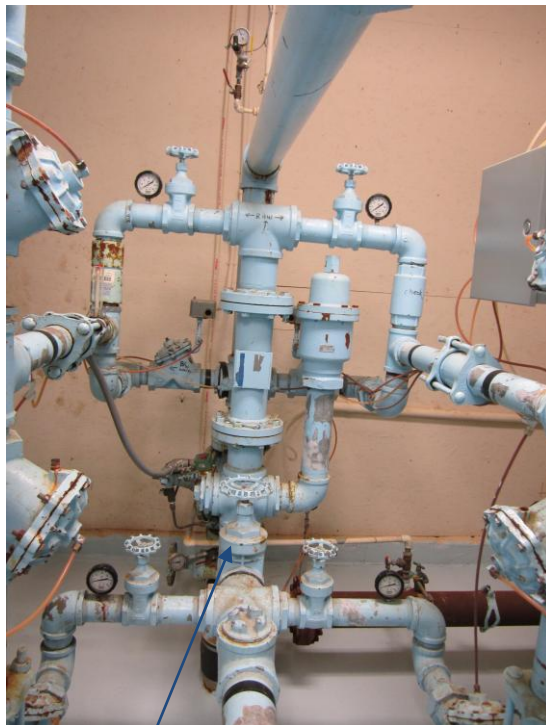
*Raw water connection with pre-filtration feed line*

A gate valve is installed between the raw water line and the pre-filtration line. The connection, however, does not pose a health risk as it does not allow raw water to co-mingle with final filtrate, and is not considered a cross connection as the raw water supply is not physically connected to the finished water supply.

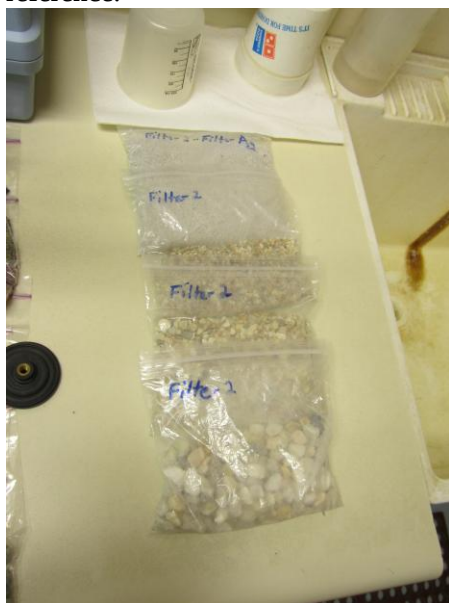
Clarifier media – pre filter #2

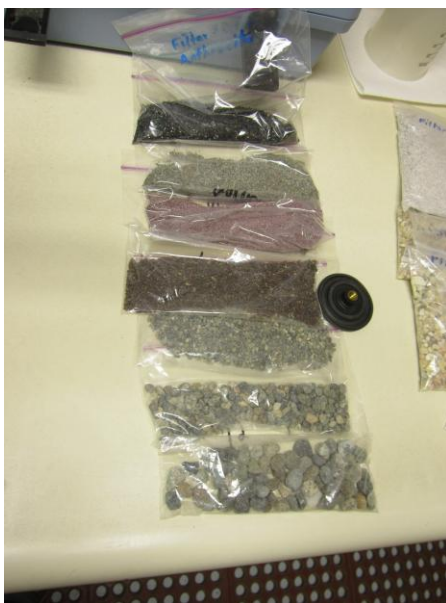
Final filter media – filter #4

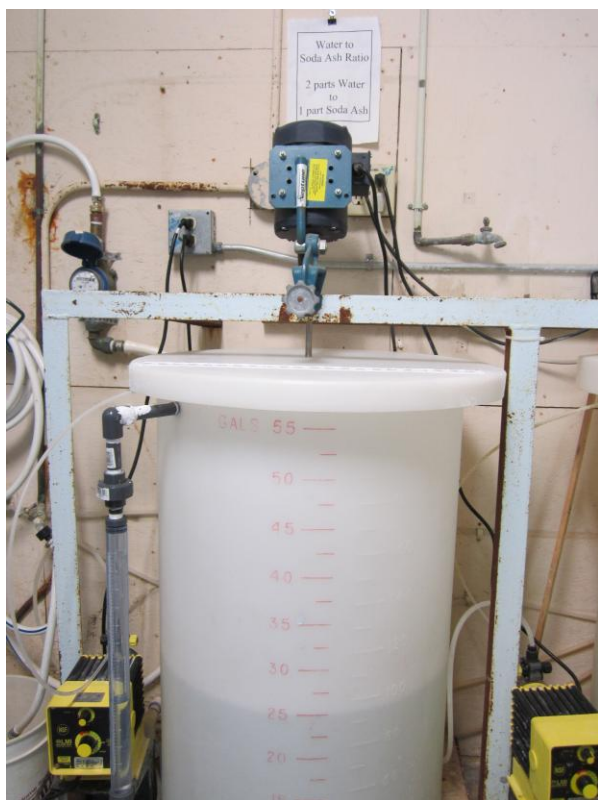
*Soda ash injection system*

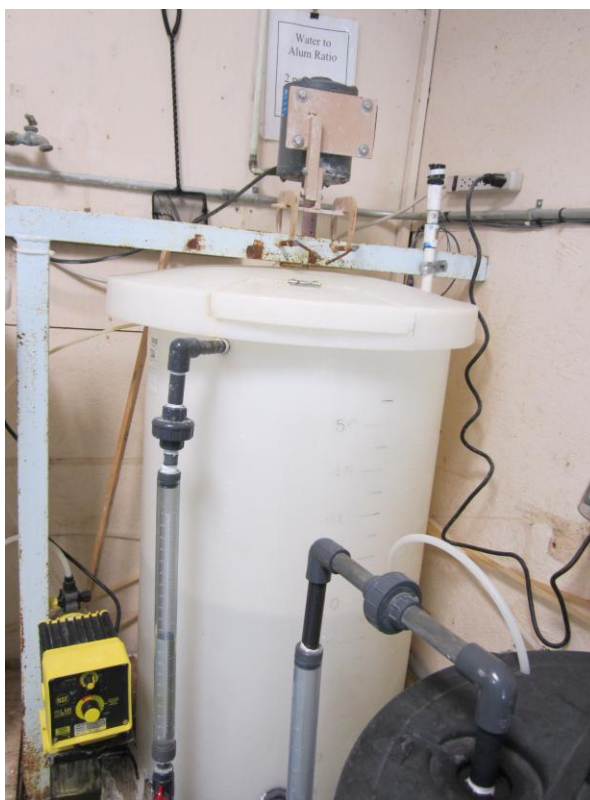
*Alum injection system*

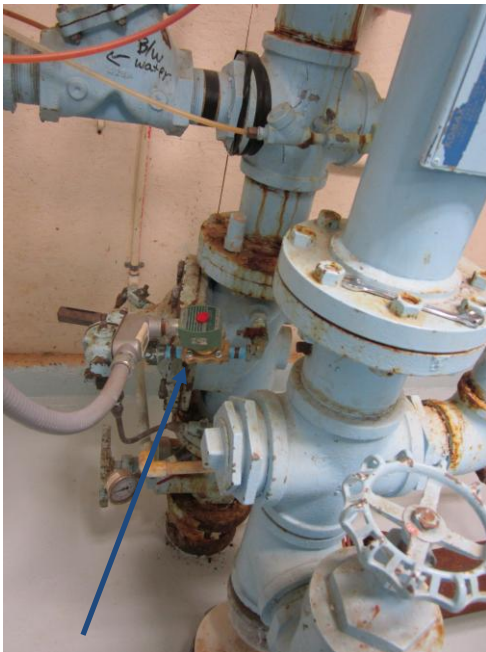
The operator has done an excellent job maintaining the PRV, which is a critical component of the backwash cycle. Automated control valves have also been well maintained in order to preclude backwash water from comingling with the potable water supply.

*Backwash water PRV*

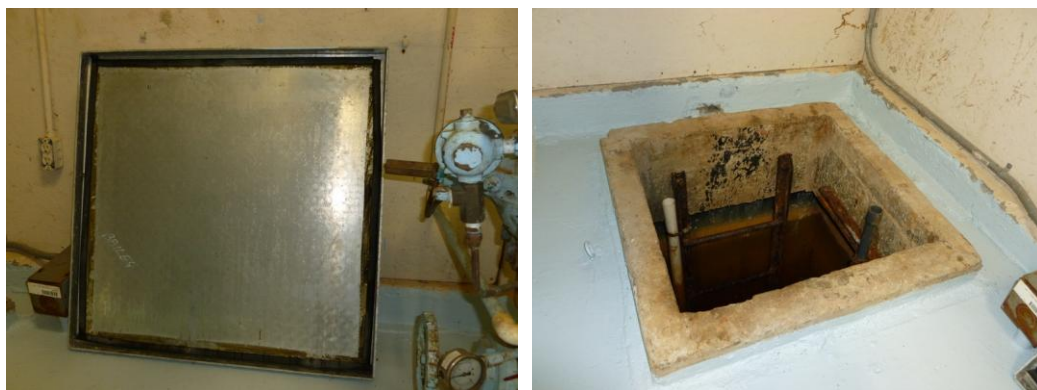
*Contact chamber with adequate gasket on reservoir hatch and contact chamber opening*

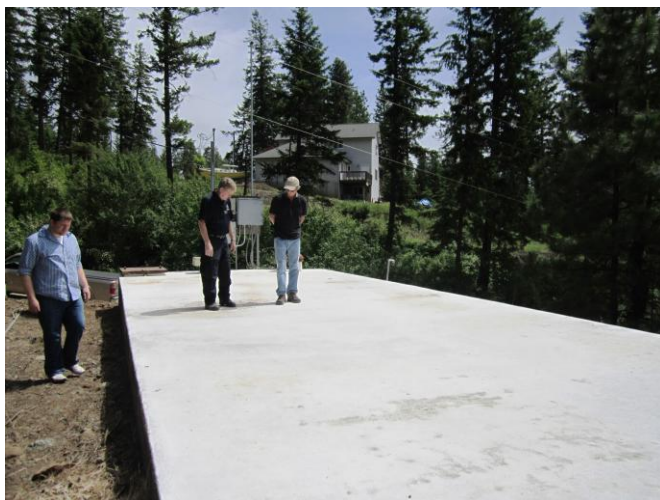
The reservoir roof coating was found to be bubbling in some areas and operator Dave Banks reports the reservoir is scheduled to be recoated. The reservoir is equipped with a drain and a shared vent/overflow found to be adequately screened with 24 stainless steel mesh. The interior gasket of the Midway reservoir hatch was found to be in good repair. The interior of the reservoir was found to be well maintained; no accumulations of sediment were observed on the reservoir floor.

*30,000 gallon Midway reservoir*

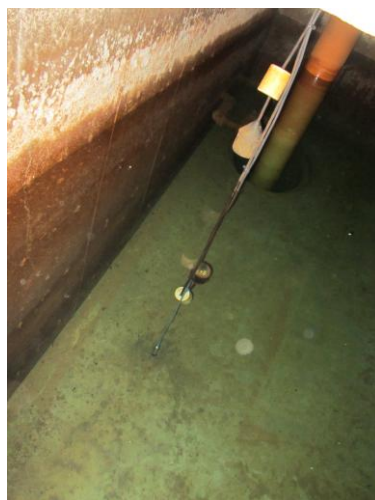
*Midway reservoir floats and pressure transducer*

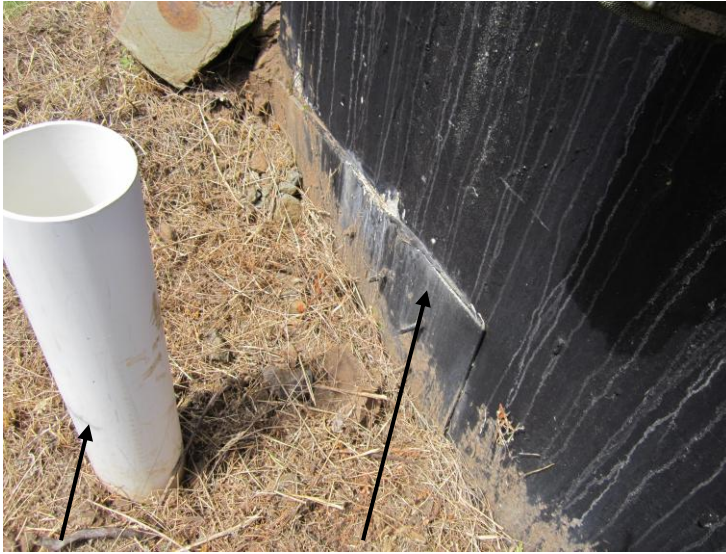
Leak repair of the northwest corner of the reservoir has been completed since the time of the last survey. As part of the repair, the corner was reinforced with a steel brace. Bolts for the brace do not extend through the concrete to potable water.

*Drain valve*

*Midway reservoir steel corner brace*

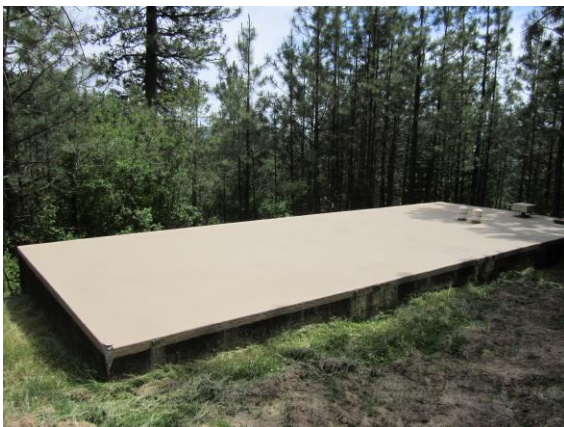
*30,000 gallon upper reservoir*

The northeast corner of the reservoir appears to have been broken off by excavation equipment and requires repair.

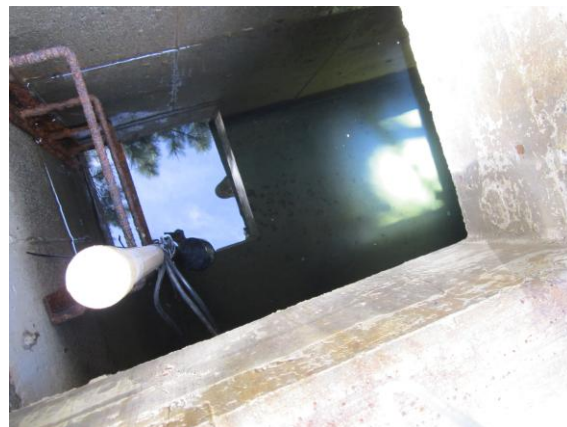
*Upper reservoir interior*

The reservoir hatch was found to be secure. The interior of the reservoir was found to be well maintained; no accumulations of sediment were observed on the reservoir floor.

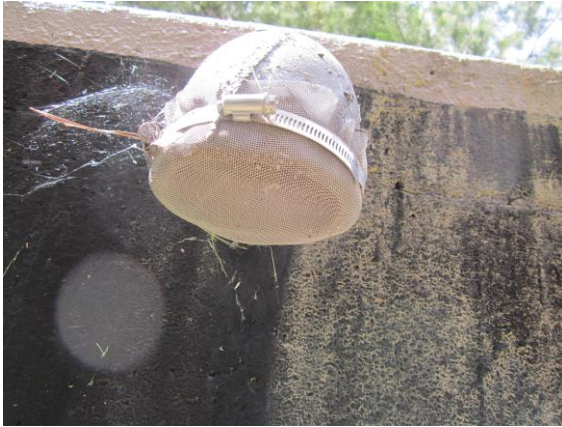
*Upper reservoir vent/overflow*
